THE UNITED STATES
STRATEGIC BOMBING SURVEY

THE EFFECTS
OF
THE ATOMIC BOMB
ON
HIROSHIMA, JAPAN

Volume III

Physical Damage Division

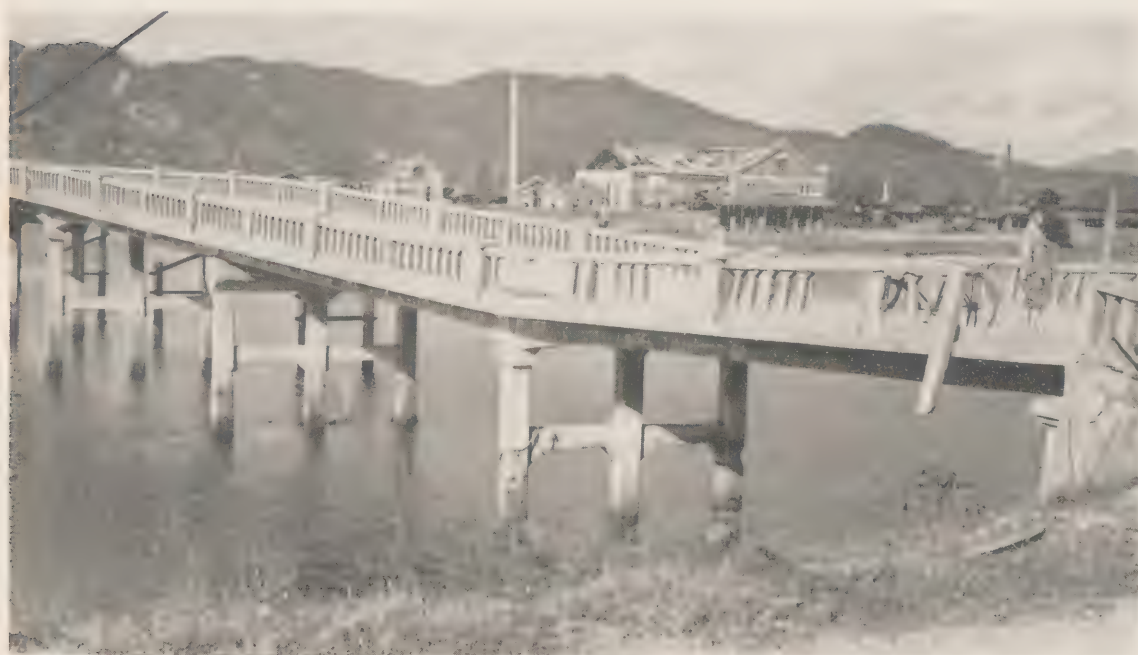
(14) *Bridge 45* (7,010 feet from GZ and 7,300 feet from AZ). The spans and bents adjacent to the east abutment were moderately damaged by flood (Photo 102).

PHOTO 102-XII. Bridge 45. Looking northwest at the southeast area of the concrete highway bridge over the Fukushima-Gawa. Moderately damaged by flood (7,010 feet to GZ, 7,010 feet to AZ).

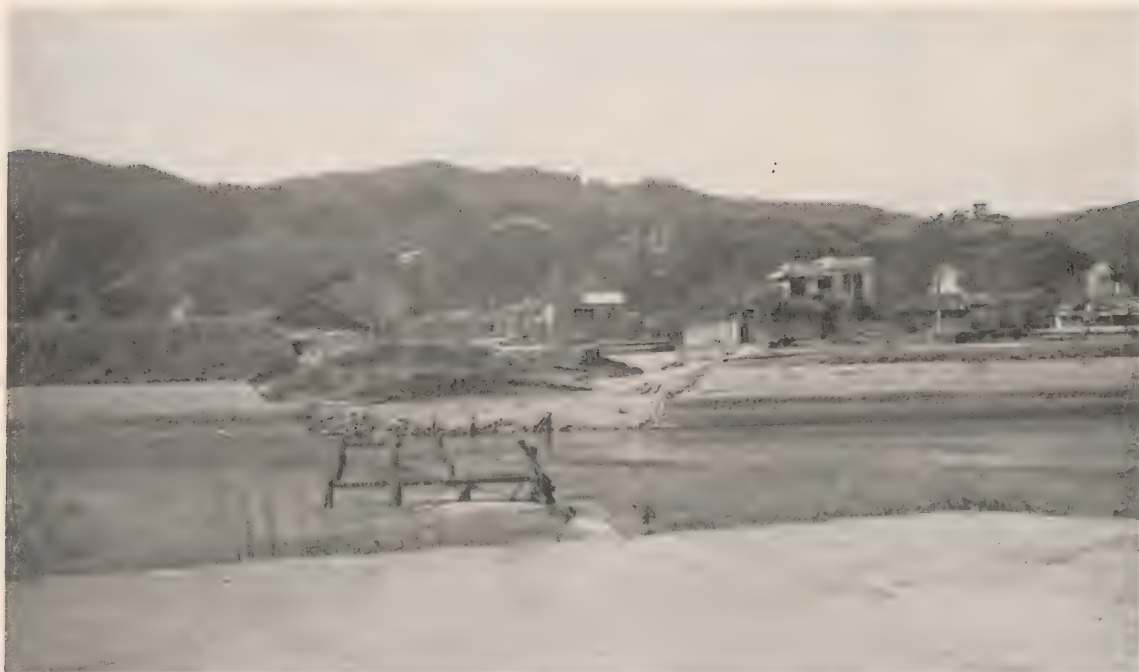
(18) *Bridge 46* (8,090 feet from GZ and 8,350 feet from AZ) was totally damaged by flood (Photo 103).

PHOTO 103-XII. Bridge 46. Looking west at remains of timber bridge over the Yamate-Gawa. Totally damaged by flood (8,090 feet to GZ, 8,350 feet to AZ).

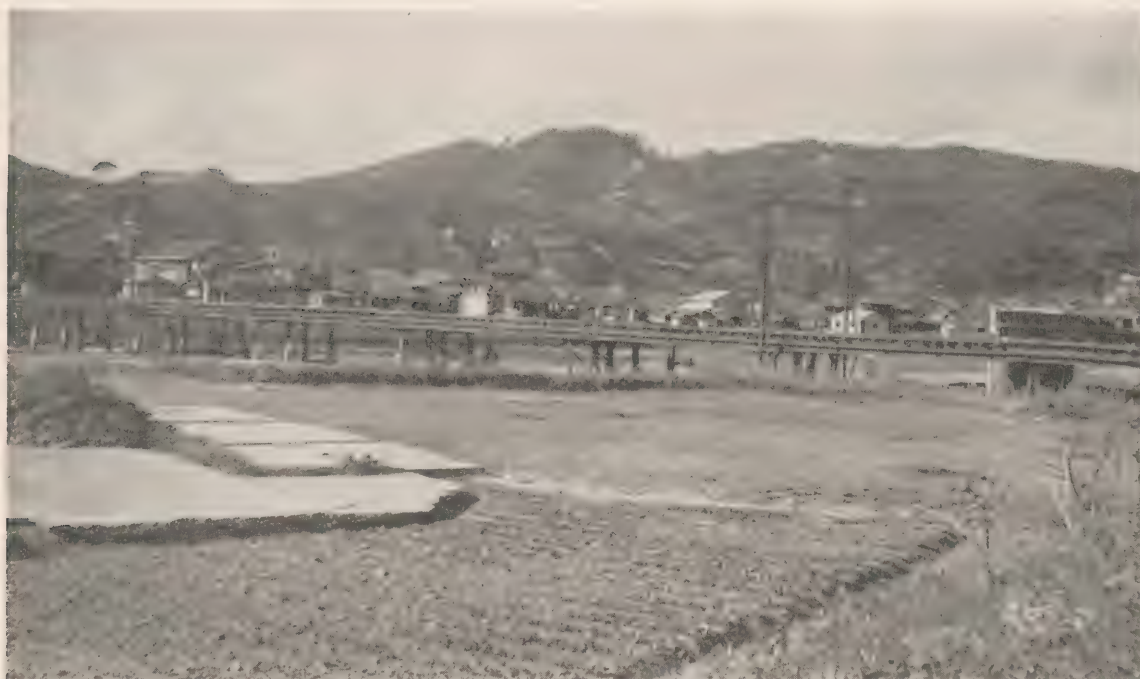
(20) *Bridge 47* (7,450 feet from GZ and 7,700 feet from AZ) suffered no damage (Photo 104).

PHOTO 104-XII. Bridge 47. Looking north at undamaged trolley bridge over the Yamate-Gawa (7,450 feet to GZ, 7,700 feet to AZ).

BRIDGE 47
 DOUBLE TRACK TROLLEY STRUCTURE SIMILAR TO BRIDGE 13.
 10 SPANS AT 34'. LENGTH = 340'.
 WIDTH = 16'.
 8 7"x24" I-BEAM GIRDERS.
 DISTANCE TO G Z = 7450'.
 SEE PHOTO 104.

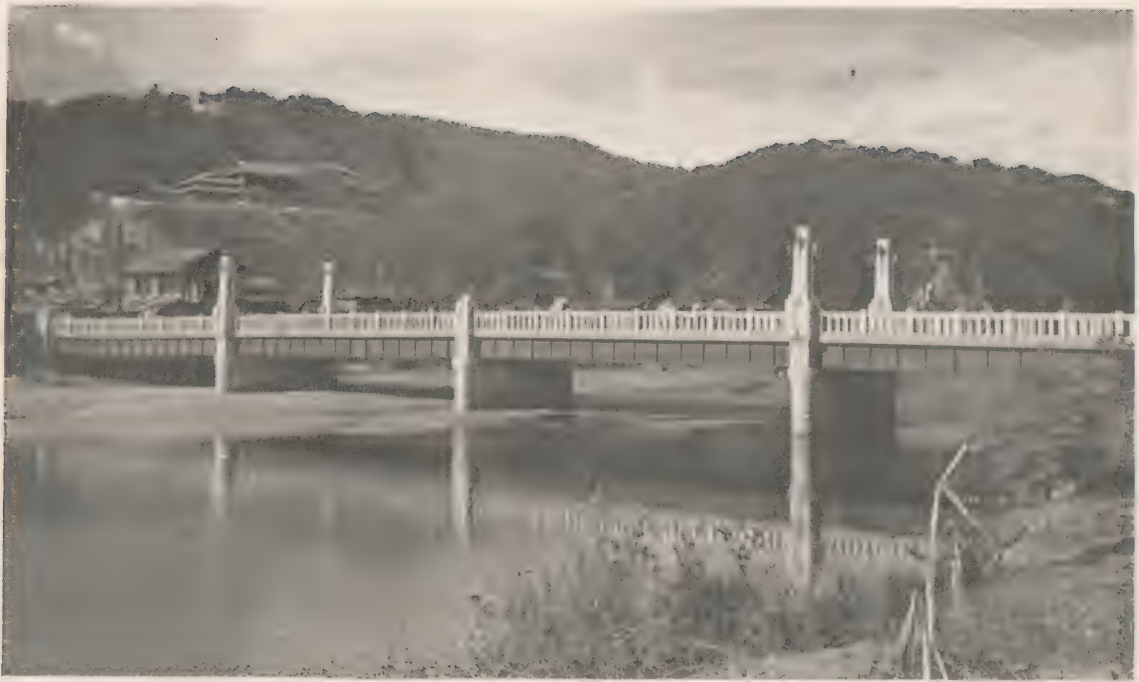
(21) *Bridge 48* (7,130 feet from GZ and 7,400 feet from AZ) suffered no damage (Photo 105).

PHOTO 105-XII. Bridge 48. Looking north at undamaged plate-girder, concrete-deck, highway bridge over the Yamate-Gawa; 12- and 14-inch water mains are carried by steel saddles between girders (7,130 feet to GZ, 7,400 feet to AZ).

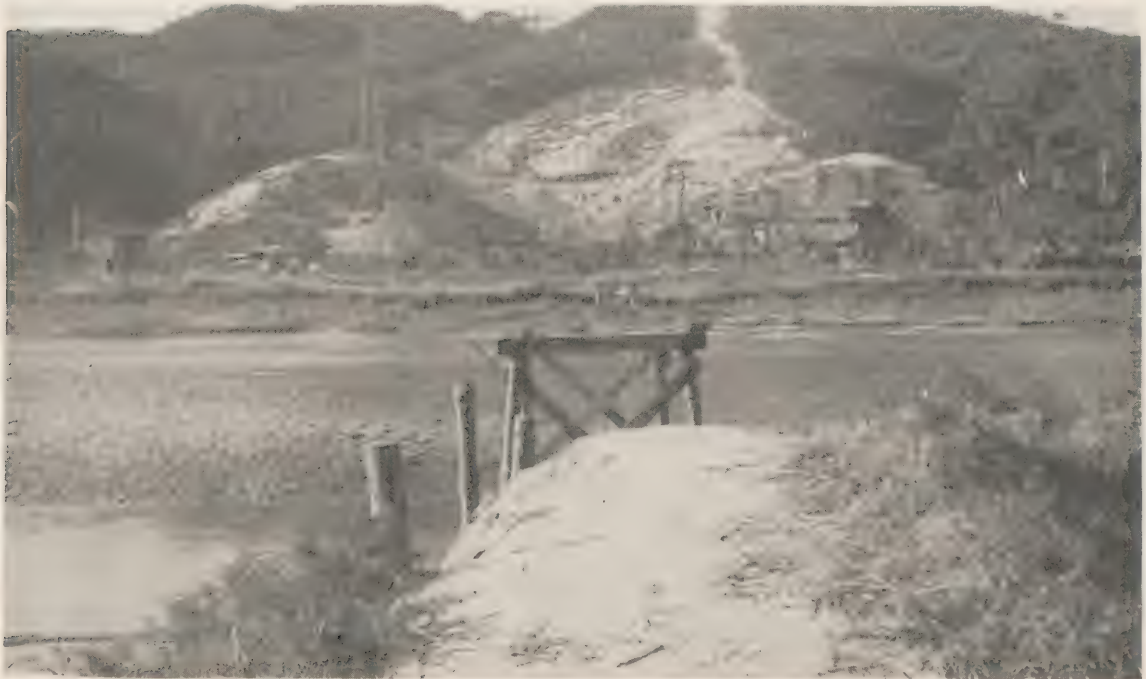
(19) *Bridge 49* (6,380 feet from GZ and 6,650 feet from AZ) was totally damaged by flood (Photo 106).

PHOTO 106-XII. Bridge 49. Looking northwest at remains of timber foot bridge over the Yamate-Gawa. Totally damaged by flood (6,380 feet to GZ, 6,650 feet to AZ).

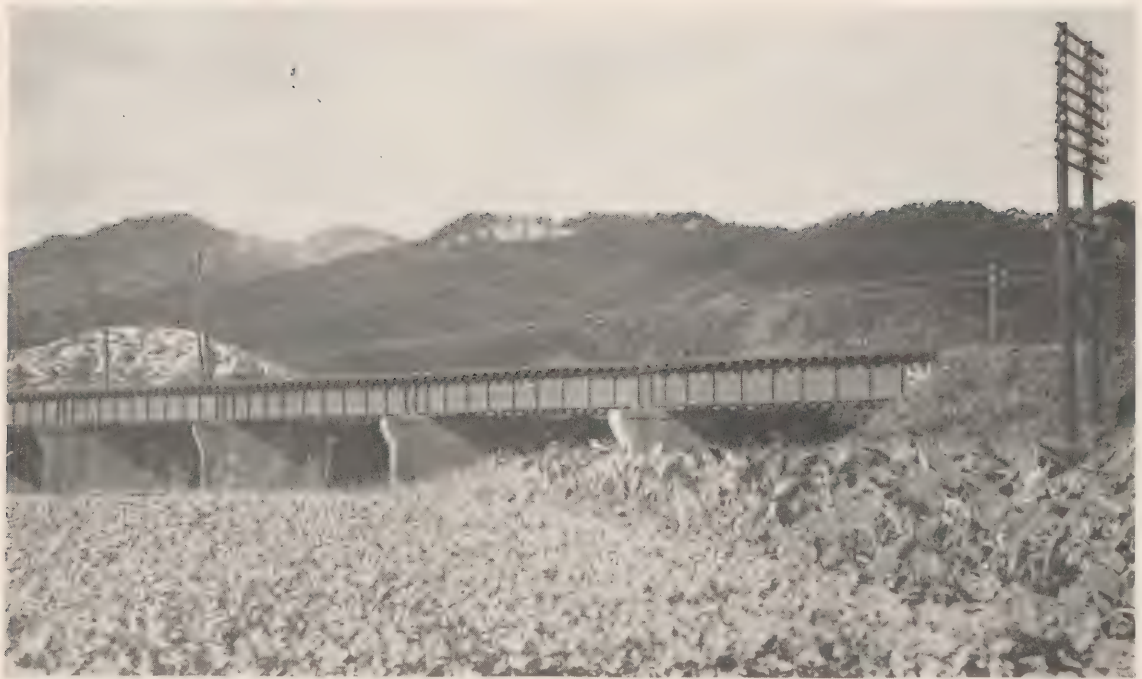
(22) *Bridge 50* (6,580 feet from GZ and 6,900 feet from AZ) suffered no structural damage, and the only bomb effect noted was discoloration of the old paint on the steel members along the south side facing the direction of flash. The north side was unaffected (Photo 107).

PHOTO 107-XII. Bridge 50. South elevation of undamaged, plate-girder railroad bridge over the Yamate-Gawa. Paint on girders on the south elevation was slightly discolored by exposure to bomb effects. North elevation unaffected (6,580 feet to GZ, 6,900 feet to AZ).

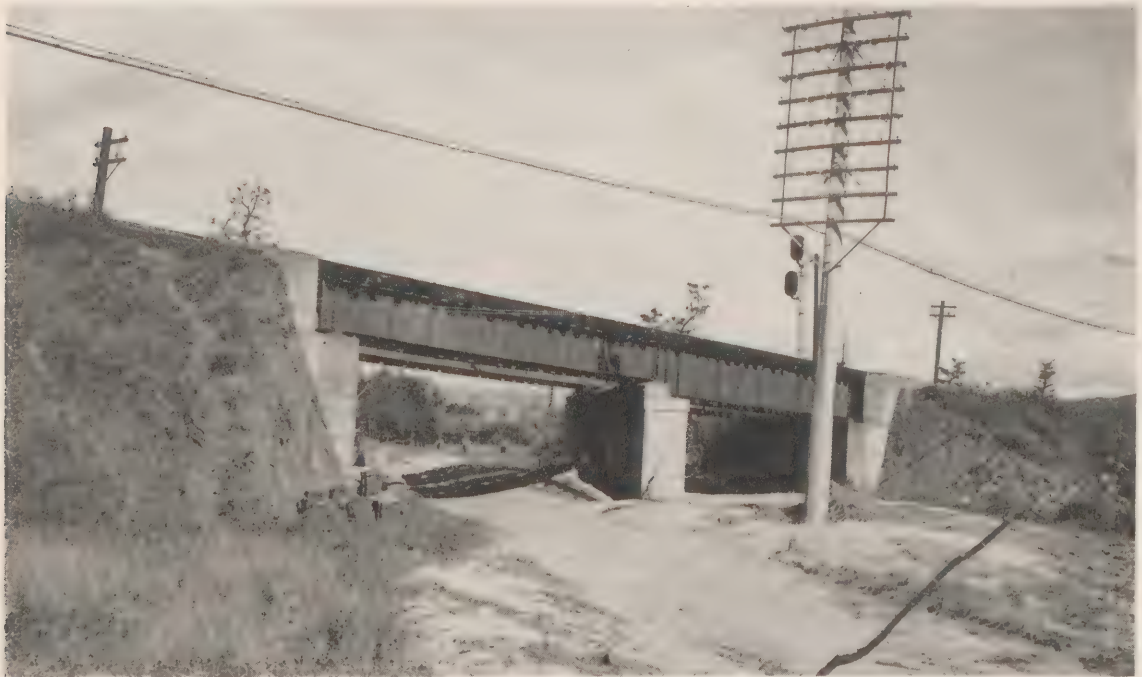
only indication of bomb effect was discoloration of the old paint on the steel members along the south side facing the direction of flash. The north side was unaffected (Photos 108 and 109).

PHOTO 108-XII. Bridge 51. South elevation of undamaged, plate-girder railroad bridge and underpass. Paint on girders on the south elevation was slightly discolored by exposure to bomb effects. North elevation was unaffected (6,450 feet to GZ, 6,780 feet to AZ).

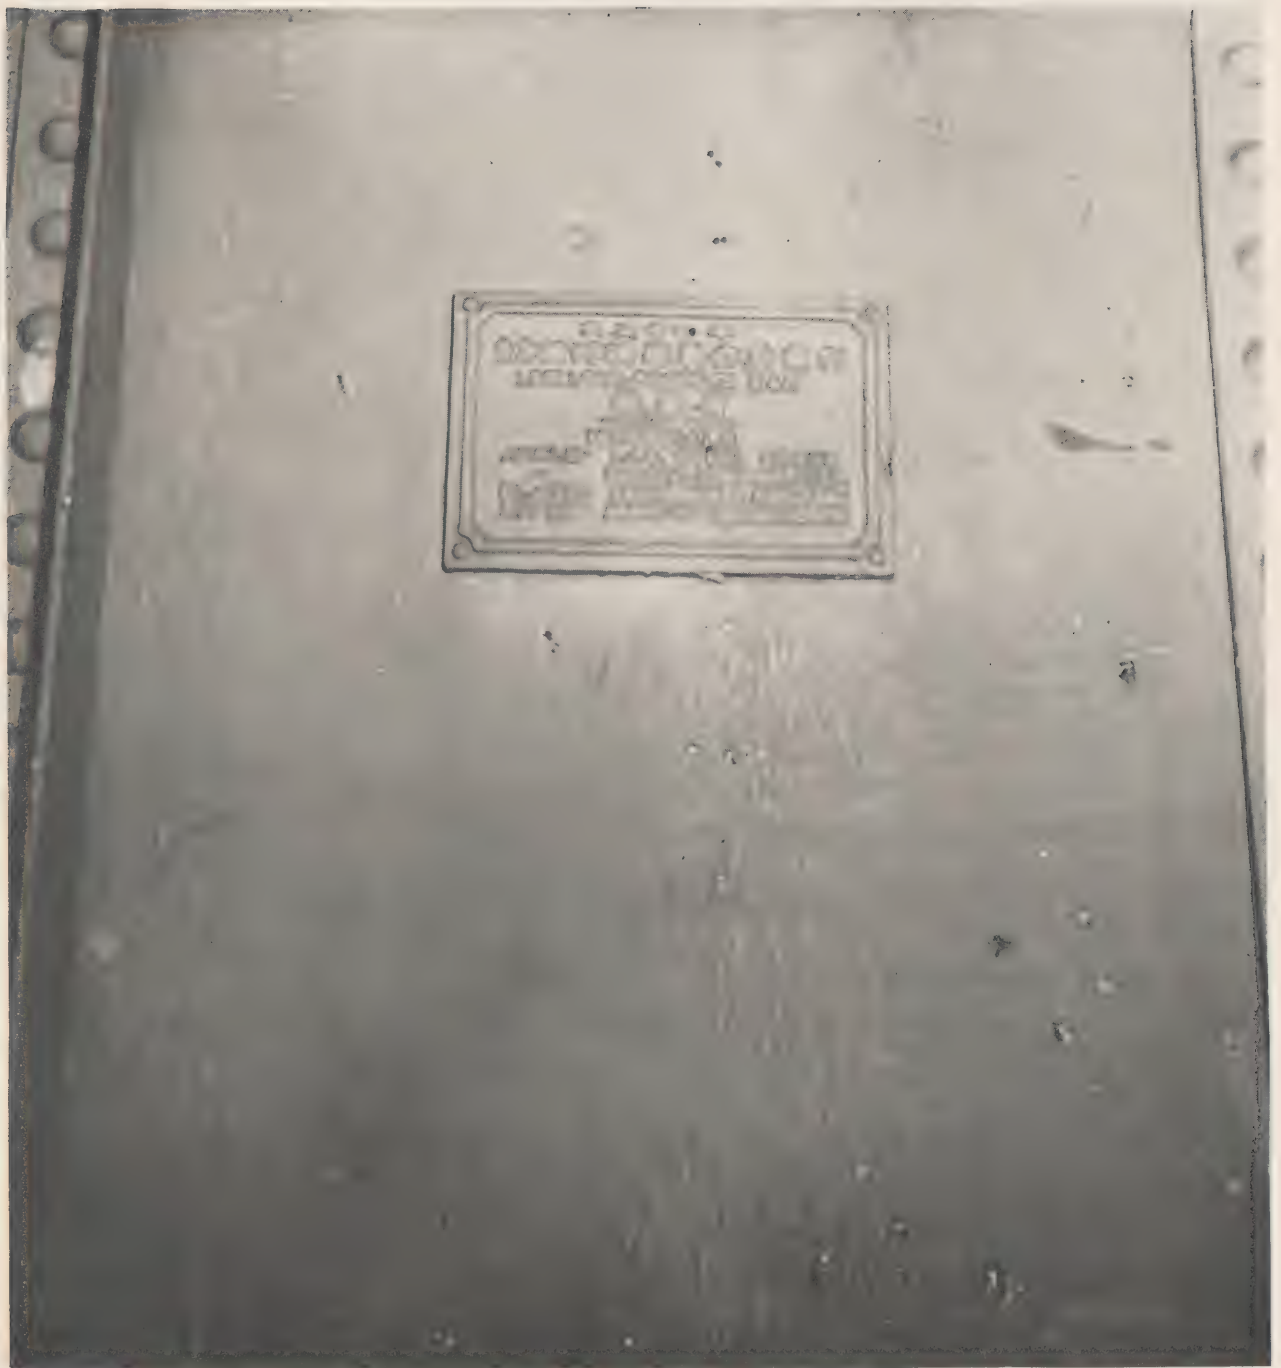
PHOTO 109-XII. Bridge 51. Cast metal sign fastened to the face of the north plate girder, showing Cooper E-40 loading, etc.

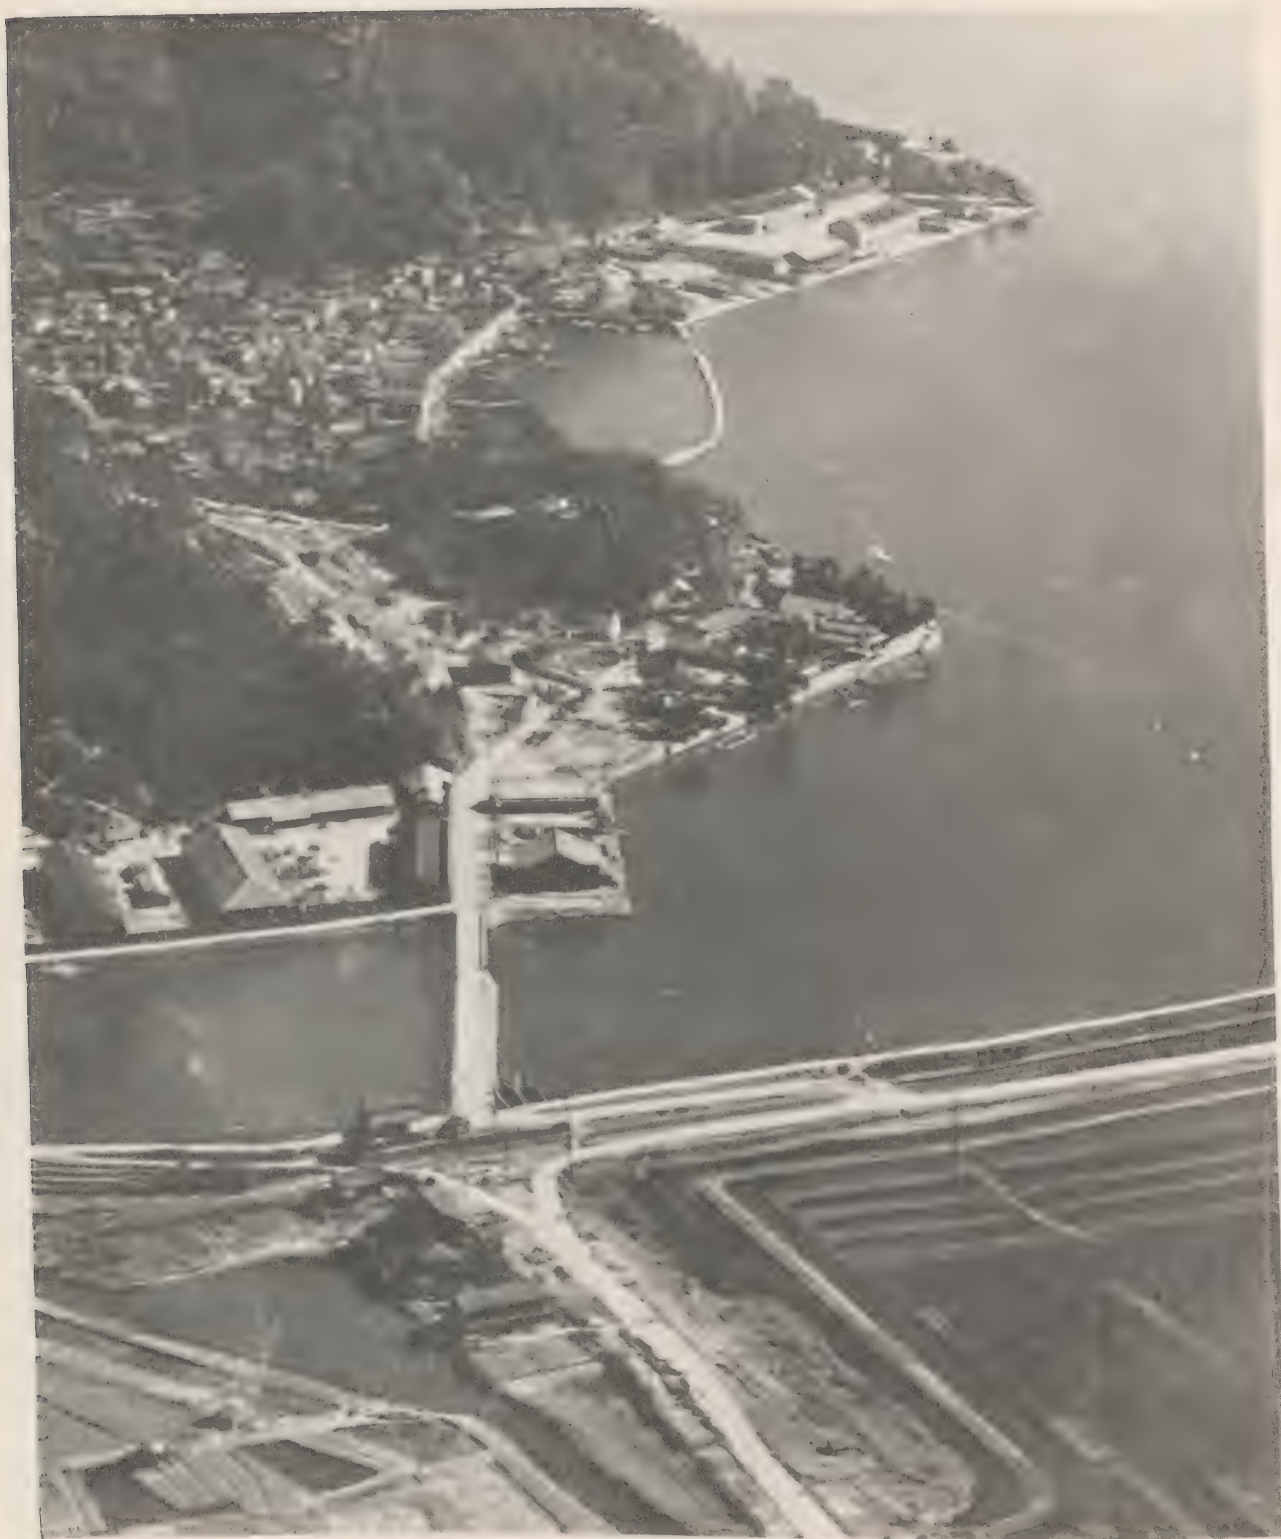
was the most distant bridge studied from GZ (Photo 110).

PHOTO 110 XII. Bridge 52. General oblique view showing most remote bridge included in study (12,200 feet to GZ, 12,450 feet to AZ).

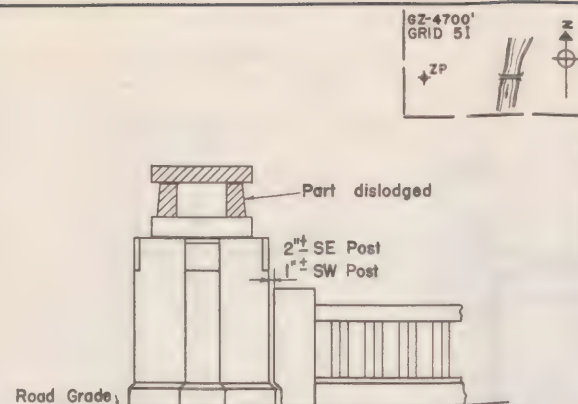
CORNER POST SKETCH
BRIDGE 12

(6) *Bridge 12* (4,700 feet from GZ and 5,100 feet from AZ). This bridge suffered no structural damage but received superficial blast damage indicated by dislodged stone ornamental posts at its southwest corners (Photos 24, 25, and 26).

SE and SW corner posts separated from railing.
Tops of NE and SE corner posts dislodged.
Top of NW corner post partly damaged.
Photos 24, 25 and 26.

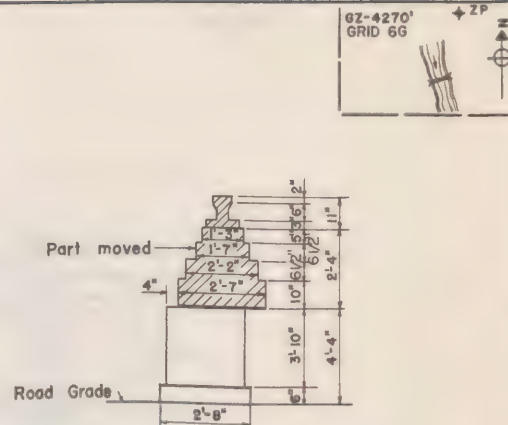
CORNER POST SKETCH
BRIDGE 19

(8) *Bridge 19* (4,270 feet from GZ and 4,720 feet from AZ). This bridge suffered no structural damage but received superficial blast damage indicated by dislodged ornamental posts (Photos 38 and 38A).

NE corner post cap blown entirely off.
NW, SE, and SW corner post caps moved 4" to 6" from original position.
Railing 3' above road grade was not disturbed.
Photo 38

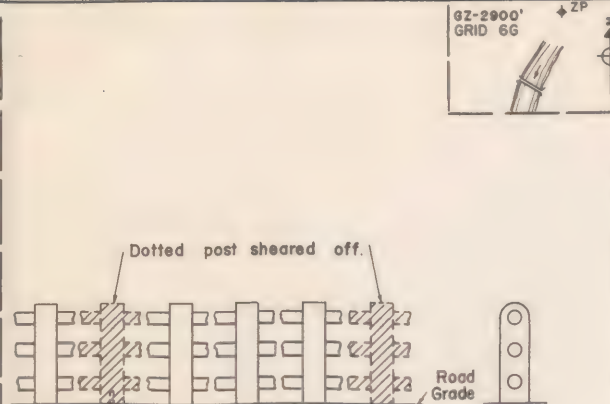
RAILING SKETCH
BRIDGE 20

(9) *Bridge 20* (I-beam girder, 2,900 feet from GZ and 3,450 feet from AZ). This bridge suffered no structural damage by blast which, however, dislodged ornamental corner posts (photos 39, 40, and 41).

Numerous railing posts connected to slab by cast iron rods sheared off.
Roadway showed shadow marks of north railing.
Tin protective covering of 18" water main on north side slightly effected by blast.
Photos 39, 40, and 41.

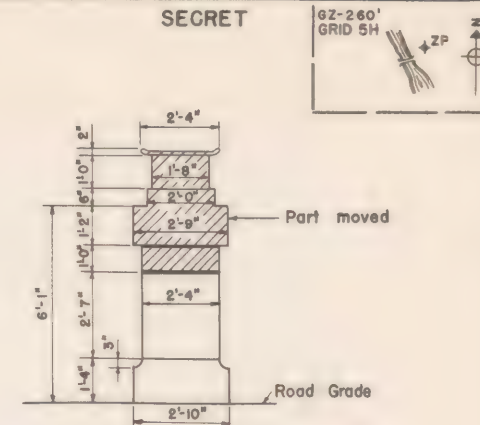
CORNER POST SKETCH
BRIDGE 22

All stone posts dislodged to some extent at road grade.
NW corner post entirely blown down.
Upper sections of the four center posts were moved 2" to 5" from original position.
Railings entirely destroyed.
Photos 43 to 46 inclusive.

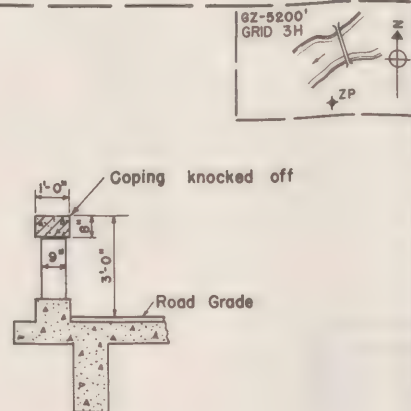
RAILING SKETCH
BRIDGE 25

(9) *Bridge 25* (5,200 feet from GZ and 5,570 feet from AZ). The fourth bent from the south abutment was completely washed out by flood, but the bridge continued to carry unrestricted traffic. It also received superficial damage when blast blew off the concrete coping along both sides and slightly damaged the railing balusters directly over each pier (Photo 71 and Fig. 13).

NE and SW corner post tops blown off.
SE corner post top displaced 4".
NW corner post top not disturbed.
Concrete railing posts over each pier broken on both south and north railings.
Coping blown off both south and north railing.
Photo 71

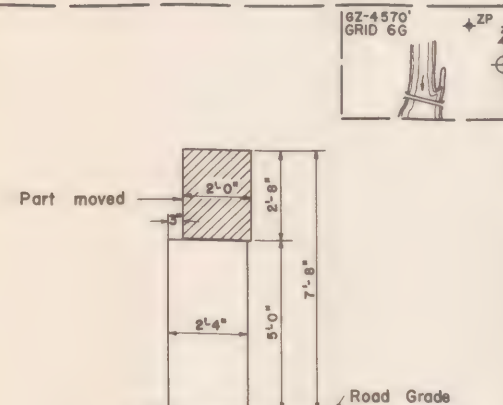
CORNER POST SKETCH
BRIDGE 31

Top portion of NW corner post dislodged 3" to south.
Other posts not damaged.
Concrete railings not damaged.
Photo 87

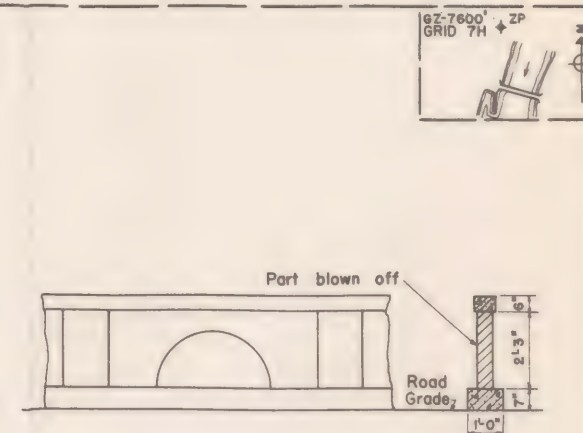
RAILING SKETCH
BRIDGE 17

Stone posts not damaged.
Railings of spans adjacent to east and west abutments were not disturbed.
All other railings blown off.
Photo 36

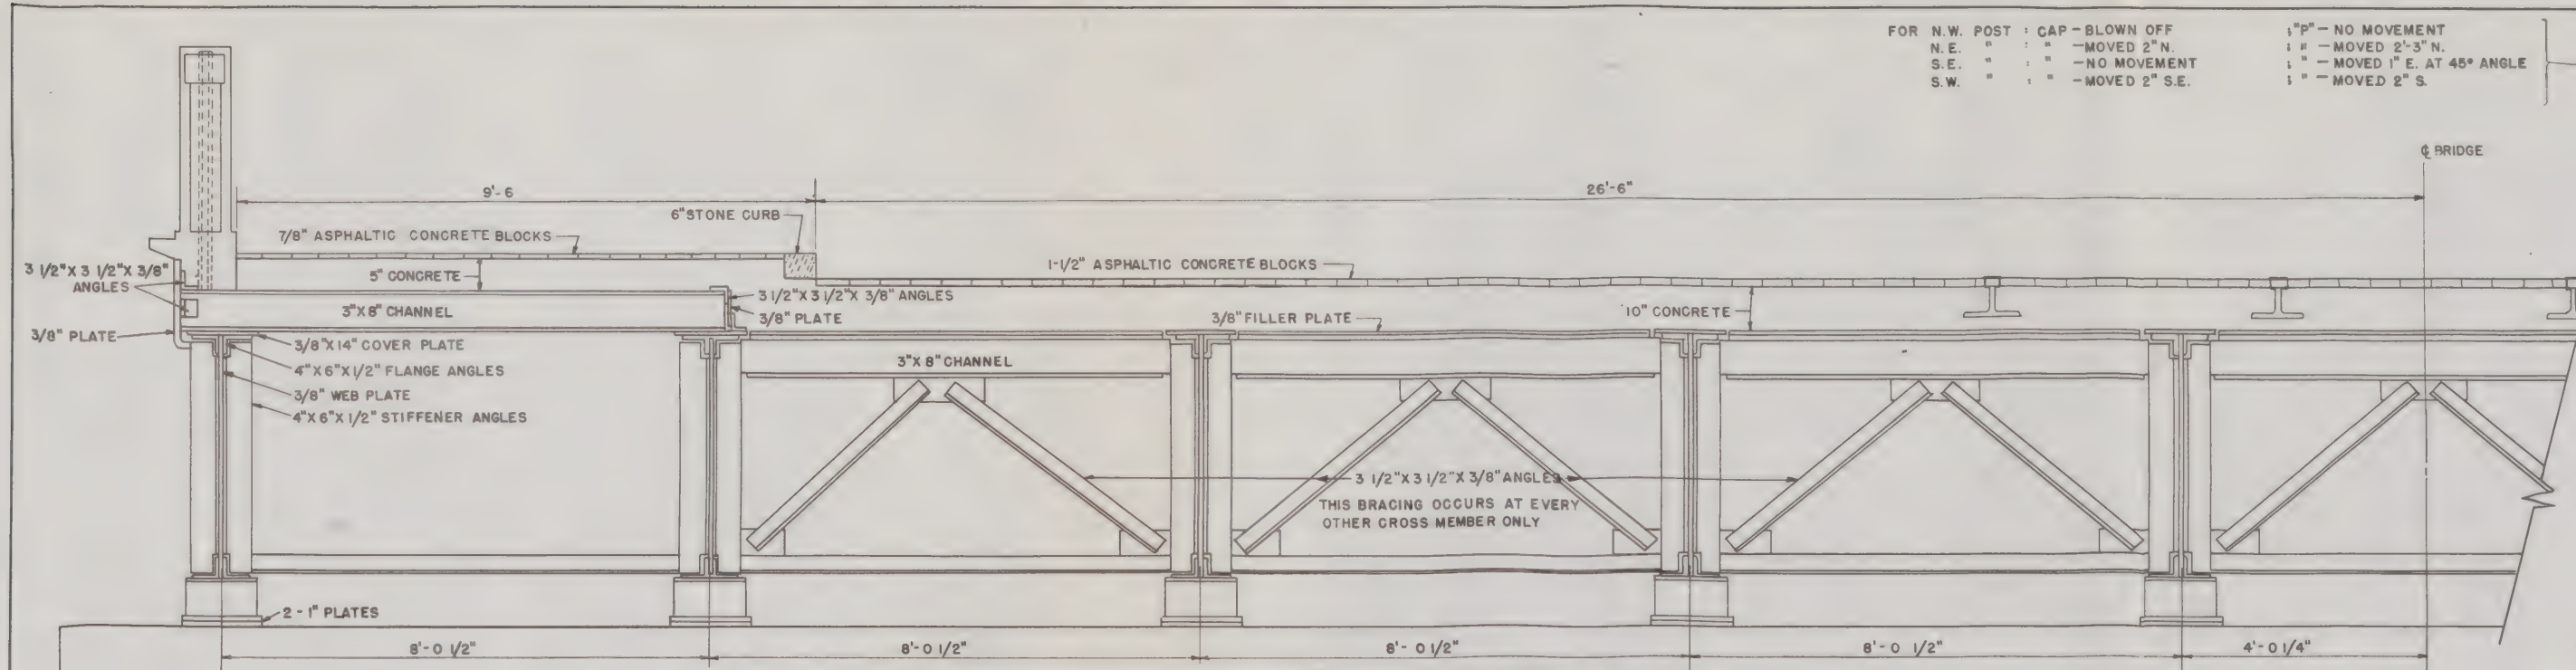
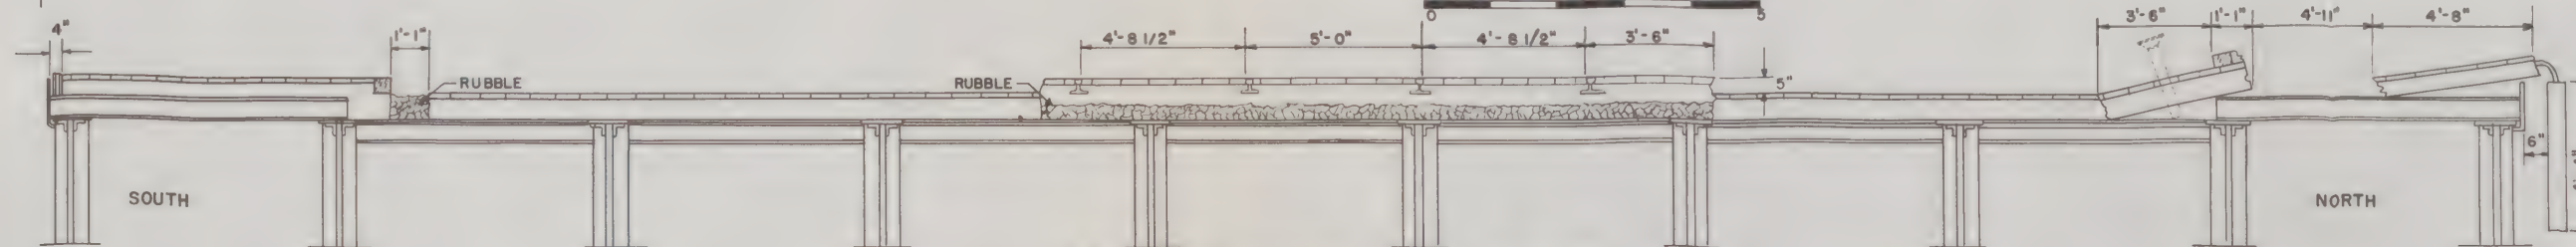
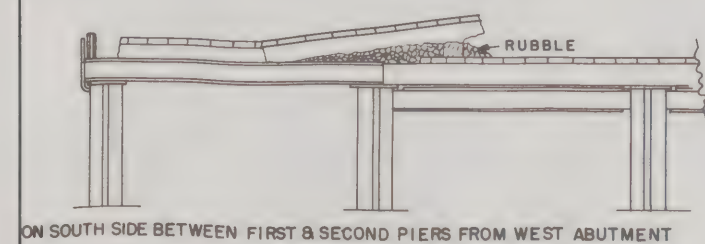
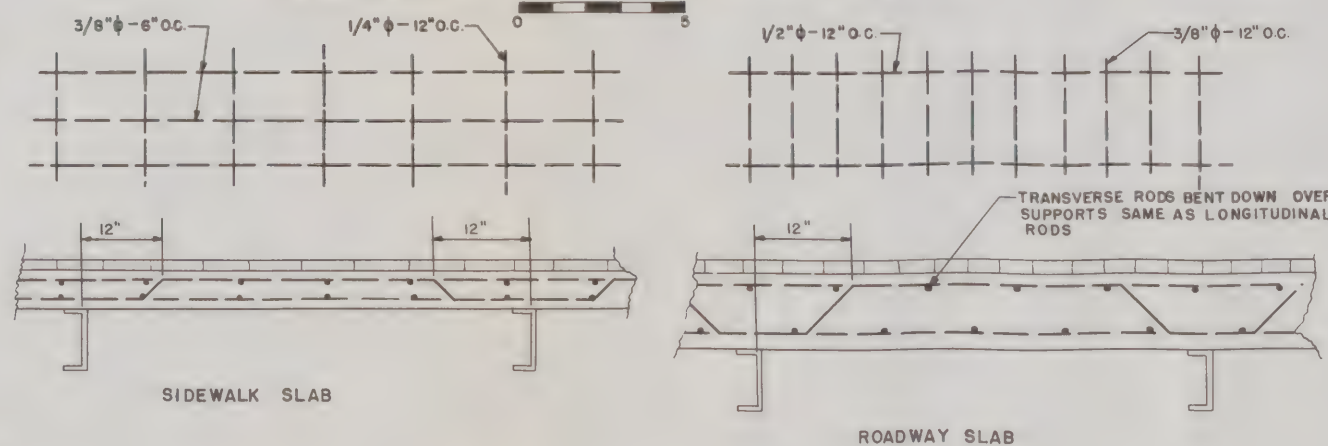
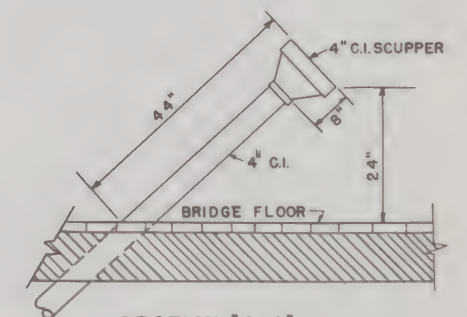
U.S. STRATEGIC BOMBING SURVEY
BRIDGE 24
HIROSHIMA, JAPAN GRID 4-H
FIGURE II - XII

SECTION SHOWING SLAB DAMAGE
 ON NORTH SIDE BETWEEN FIRST & SECOND PIERS FROM WEST ABUTMENT

ON SOUTH SIDE BETWEEN FIRST & SECOND PIERS FROM WEST ABUTMENT

SKETCH OF BLAST REACTION
 TO BRIDGE STRUCTURE

DETAIL OF SCUPPER DAMAGE

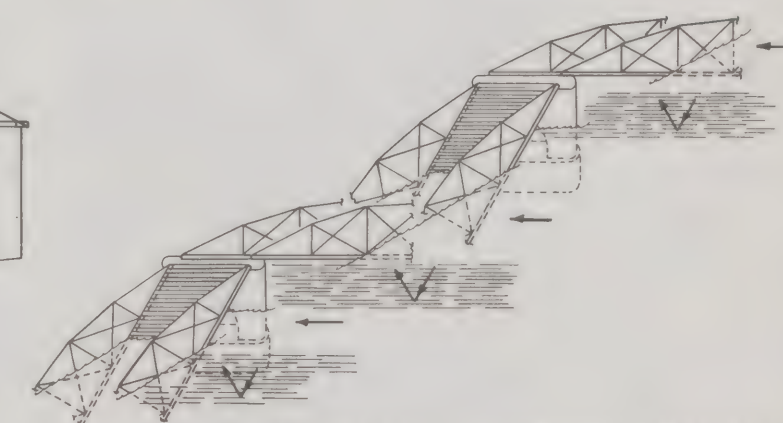
ISOMETRIC - SHOWING DAMAGE

(15) *Bridge 29* (1,190 feet from GZ and 2,310 feet from AZ), a pin-connected steel truss, was totally damaged by blast. Only stone-faced concrete piers and abutments remained. The blast forces reflected from the water struck the bridge from below and caused an uplift, while the blast striking along the sides caused overturning and failure of the structure which collapsed into the river downstream (Fig. 14). The approximate center height of the trusses was 13 feet above roadway grade. Interrogation indicated that this bridge was approximately 55 years old. It was a highway bridge of very light construction with timber deck and asphalt-wearing surface, and was in fair condition (Photos 77-80).

DAMAGE: Bomb blast struck bridge from below after rebounding from water and also struck directly at sides causing failure in members and bridge to fall downstream.

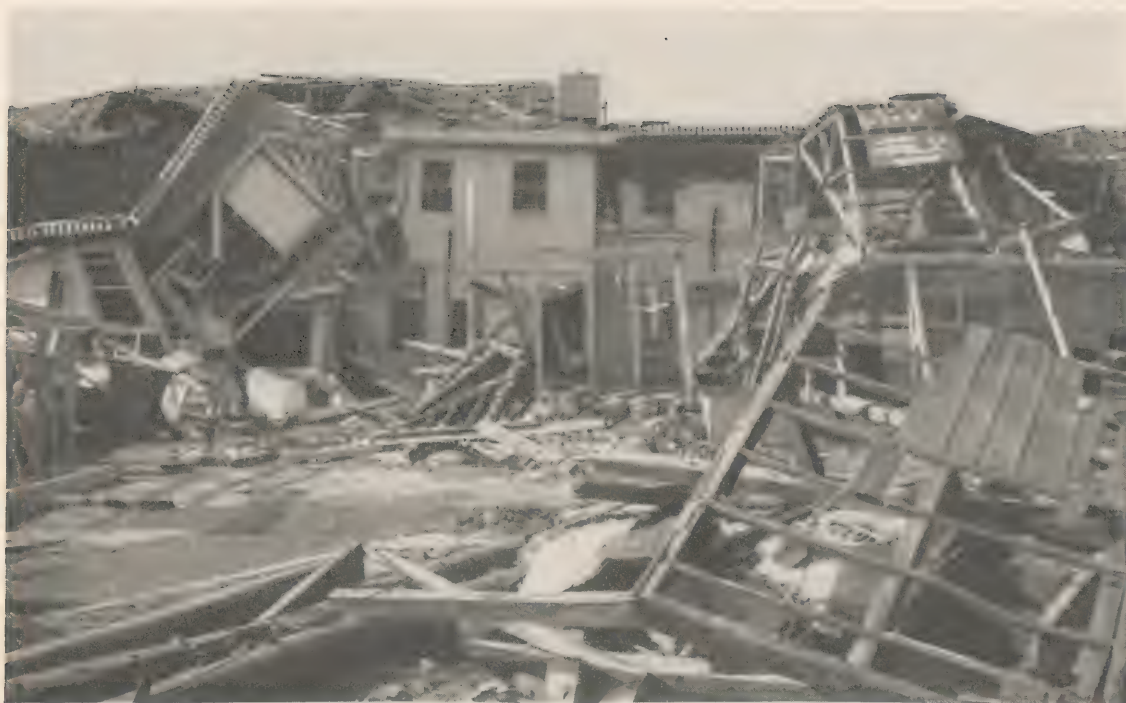
PHOTO 1-XIII. Blast damage to offices and adjacent buildings at the Sendamachi substation, 6,400 feet from GZ.

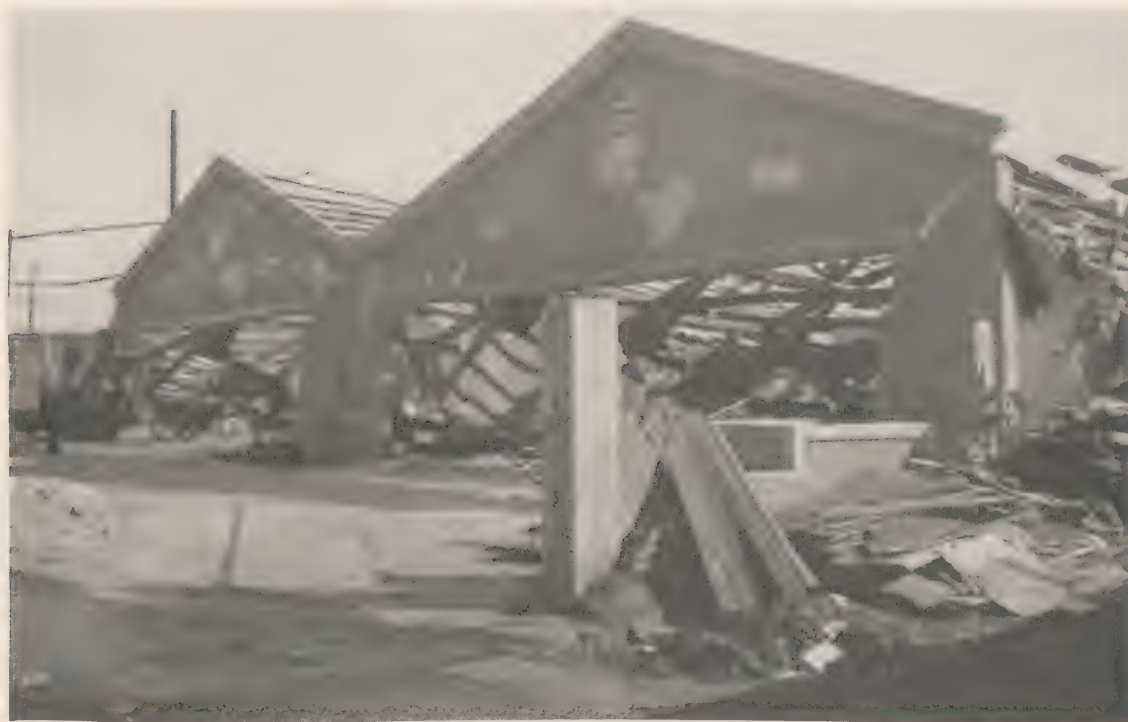
PHOTO 2-XIII. Blast damage to warehouse at the Sendamachi substation.

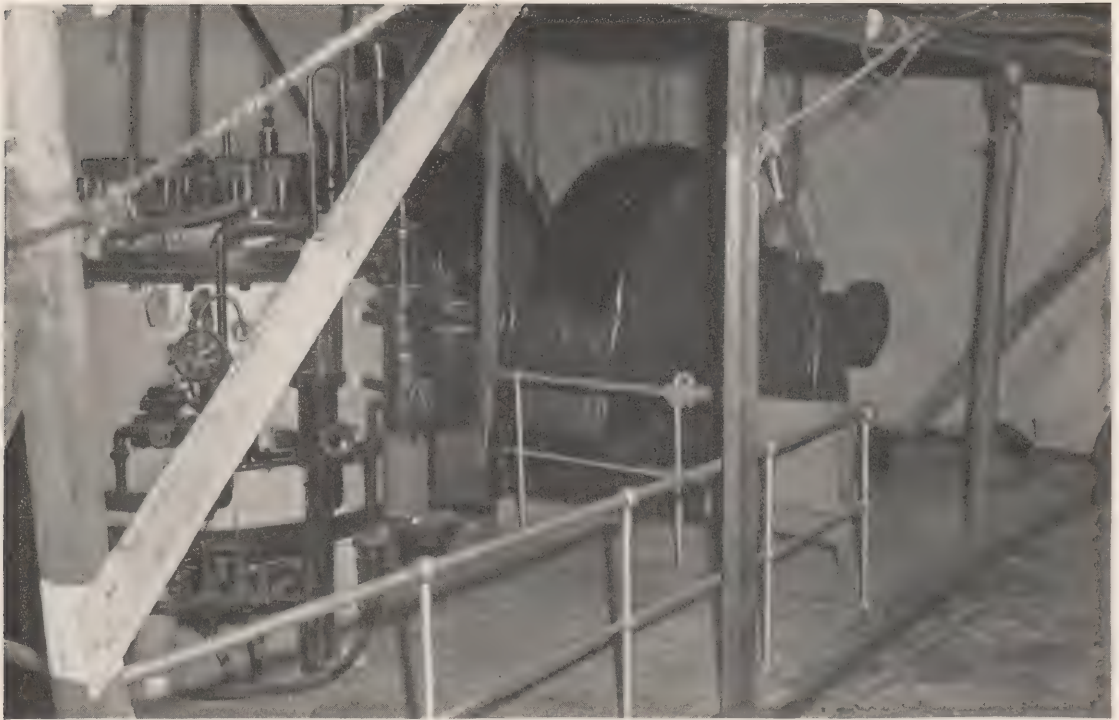
PHOTO-3-XIII. Converter equipment at Sendamachi Substation, 6,400 feet from GZ.

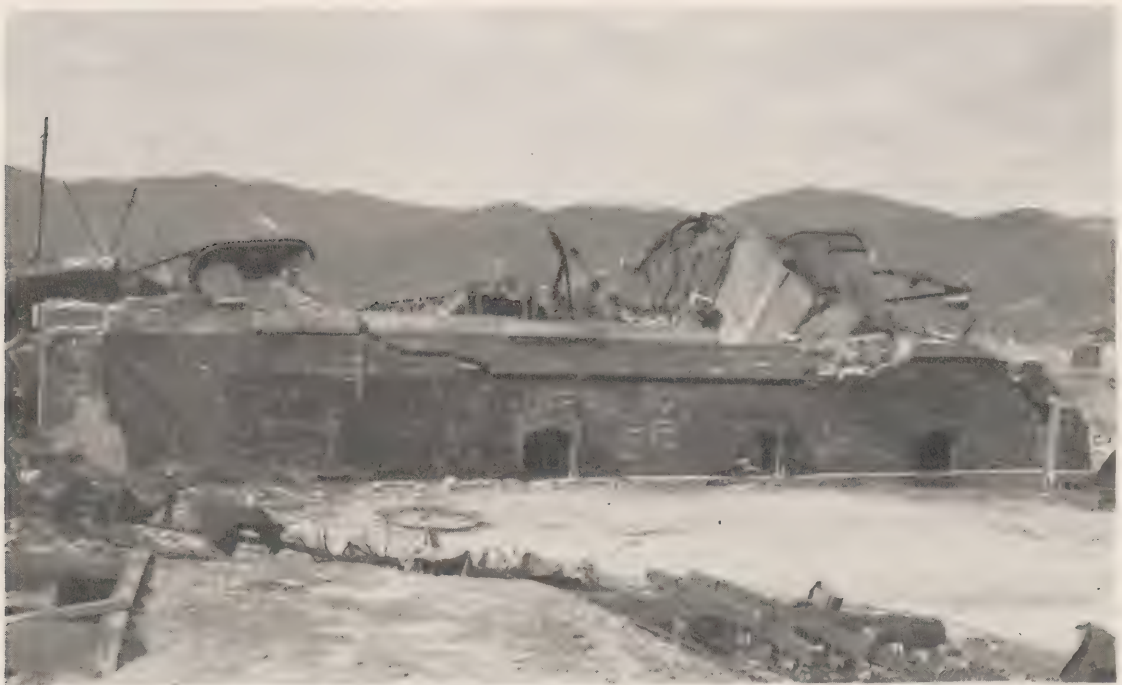
from GZ (Photo 4), suffered total damage by blast and fire. No equipment was salvageable.

PHOTO-4-XIII. Damaged converter equipment at Yagurashita substation, 900 feet from GZ.

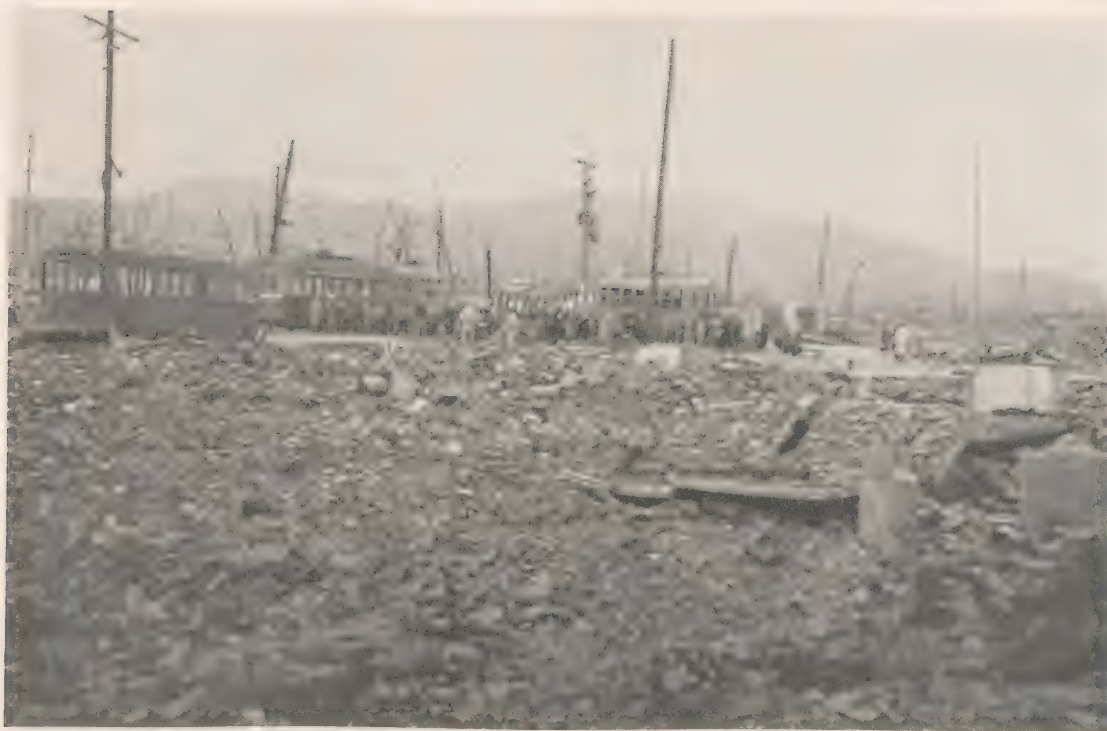
also operating in outlying vicinities. Railway officials stated that cars and buses operating within a radius of 1,500 feet of GZ (photo 5) caught fire immediately on the side facing GZ. Observations were made of damage to cars and buses within the 1,500-foot radius. Evidence of ignition by radiant heat was found in a fire lane along the tracks where burned cars had been blown by blast, substantiating the statements of the railway officials. Cars and buses were blown 30 feet, in some instances, from where they were originally standing. Buses adjacent to buildings were damaged by falling debris. This was especially true of both cars and buses that were standing in the Sendamachi station (Photos 6 and 7). Rolling stock that was burned outside the 1,500-foot radius was ignited by adjacent burning buildings (Photos 8 and 9). Buses were totally damaged 4,000 feet from GZ, and heavily damaged 5,500 feet from GZ. Damaged cars and buses standing in the roadway were removed and placed on side areas in order to facilitate traffic (Photos 10, 11, and 12). The 42 available motor buses permitted some passenger traffic to be maintained. By 9 August 1945 the converter station at Sendamachi was again in operation and 8 cars were available for use, excluding 12 cars routed to Miyajima.

PHOTO 5-XIII. Damage to car at an intersection 1,000 feet east of GZ. Damaged car to left; others are in operation.

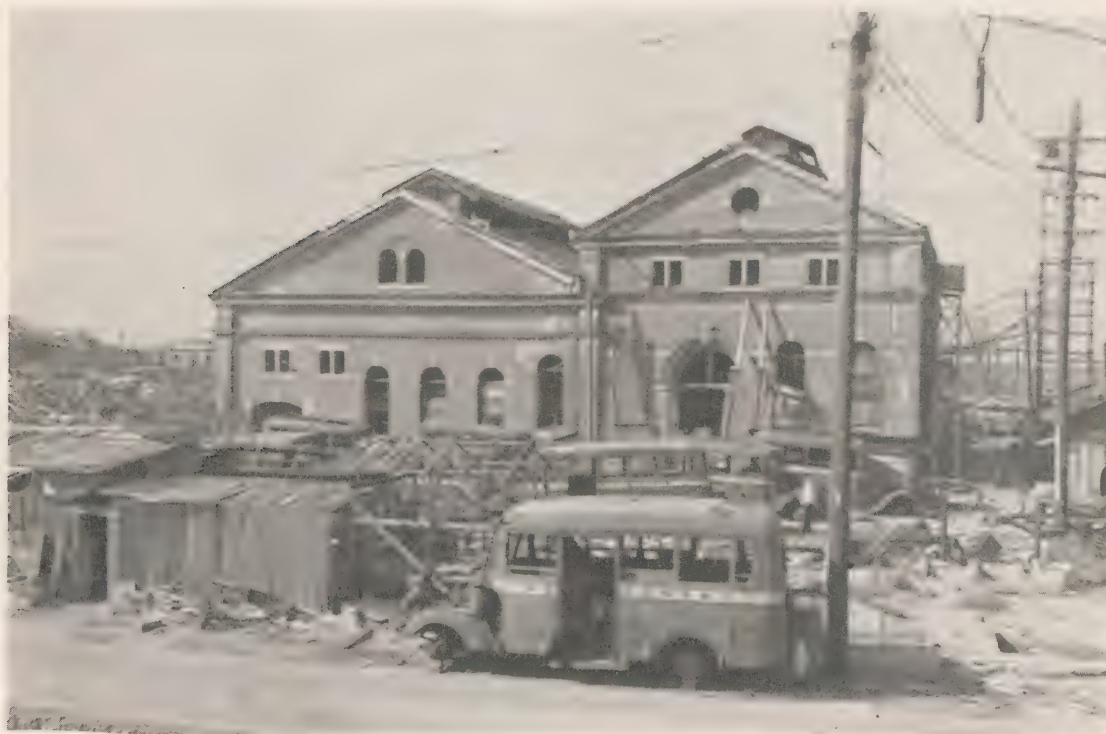
PHOTO 6-XIII. Damage to buses at the Sendamachi substation 6,400 feet from GZ.

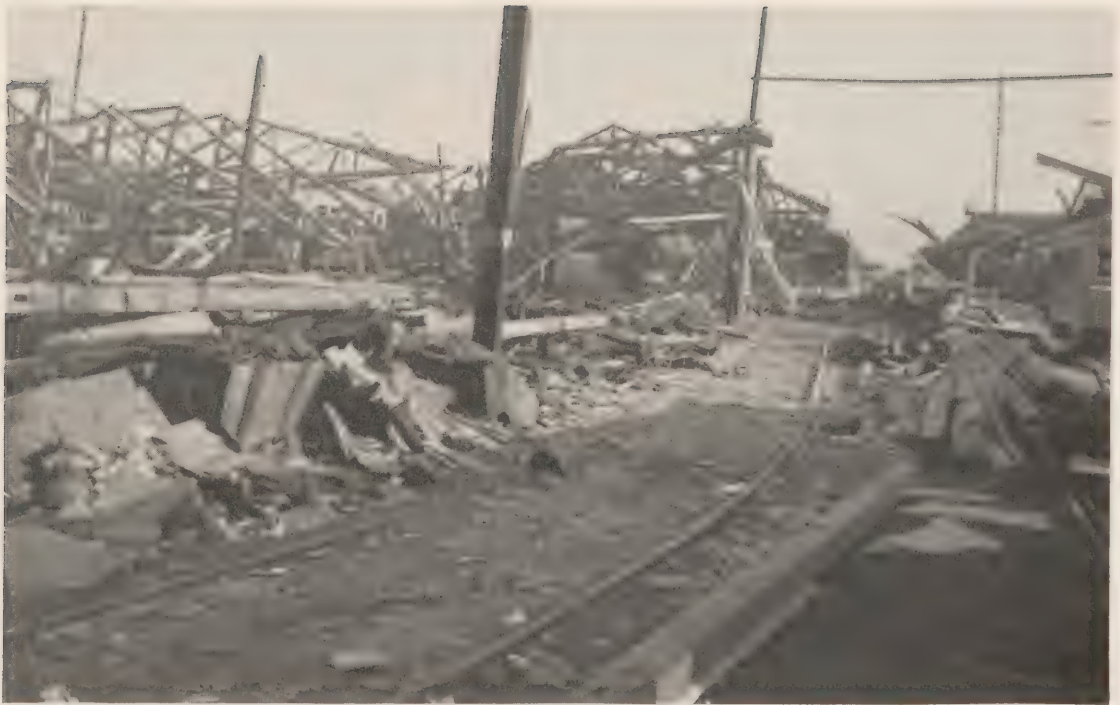
PHOTO 7-XIII. Damage to cars in car repair unit at Sendamachi substation, 6,400 feet from GZ.

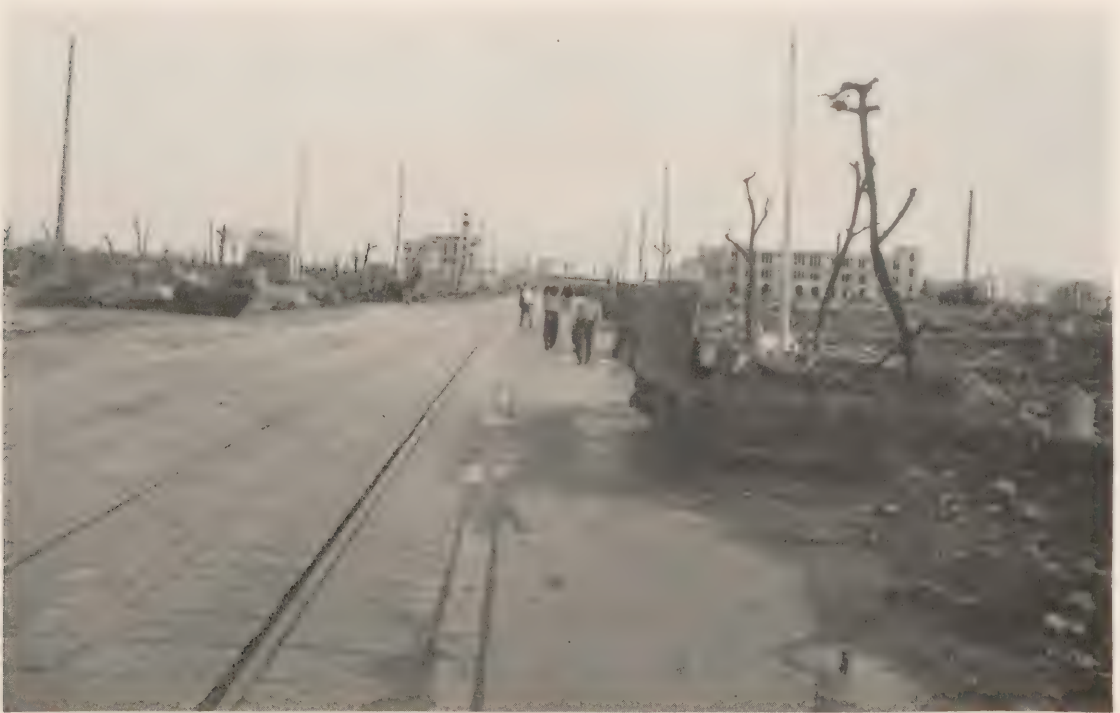
PHOTO 8-XIII. Damage to car 2,000 feet southeast of GZ.
